# **RESERVE STUDY**

## **Battlefield Green Community Association, Inc.**

**Mechanicsville, Virginia  
November 17, 2020**

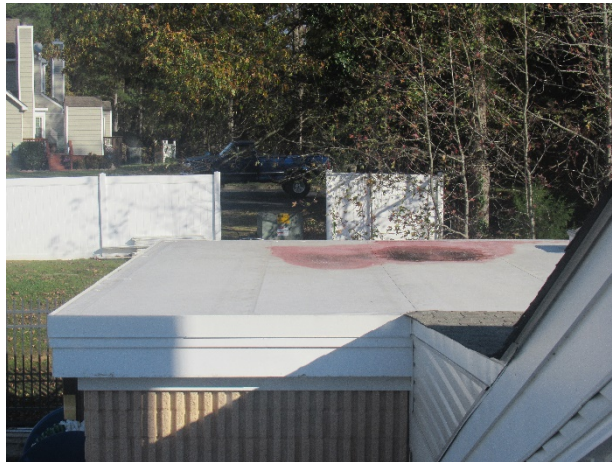
**Condition:** Good to fair overall with standing water evident. Management does not report a history of leaks.

**Thermoplastic roof overview – Note: standing water**

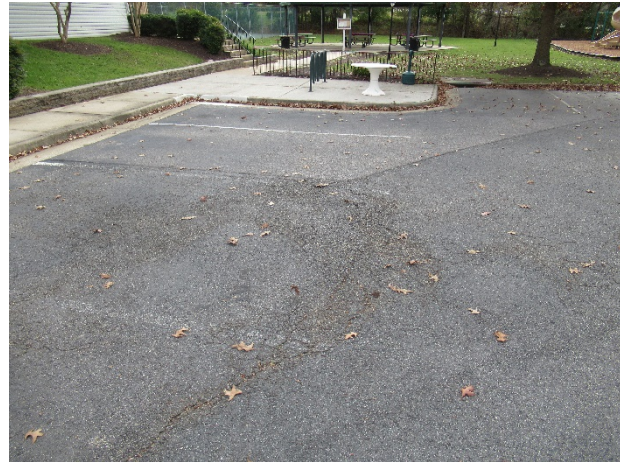
**Condition:** The asphalt pavement at the clubhouse is fair to poor overall with raveling and cracks evident. The asphalt pavement at Dugout Terrace is good overall with isolated cracks evident.

**Asphalt pavement overview – Note: raveling**

application of two or more new lifts of asphalt. We recommend mill and overlayment on asphalt pavement that exhibits normal deterioration and wear. We recommend total replacement of asphalt pavement that exhibits severe deterioration, inadequate drainage, pavement that has been overlaid multiple times in the past or where the configuration makes overlayment not possible. Based on the apparent visual condition and configuration of the asphalt pavement, we recommend the mill and overlay method for initial repaving followed by the total replacement method for subsequent repaving at the clubhouse parking area. We recommend the total replacement method of repaving for Dugout Terrace.

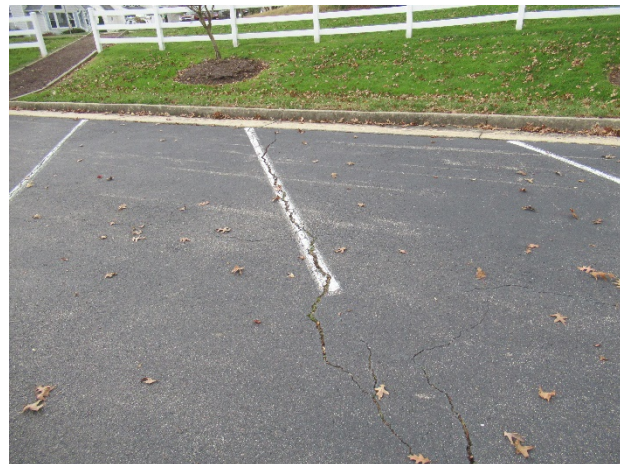
**Asphalt pavement crack**

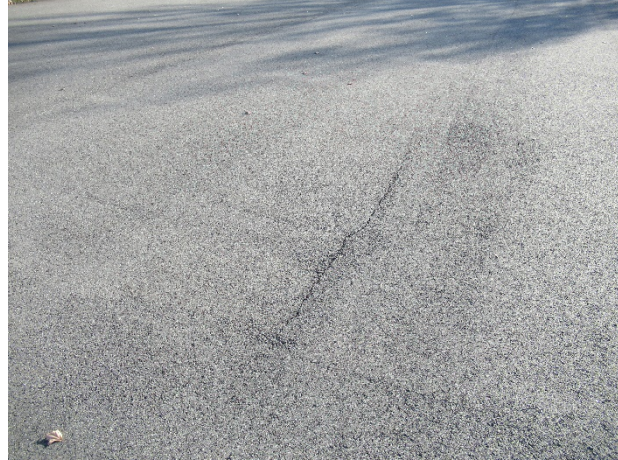
**Crack at Dugout Terrace**

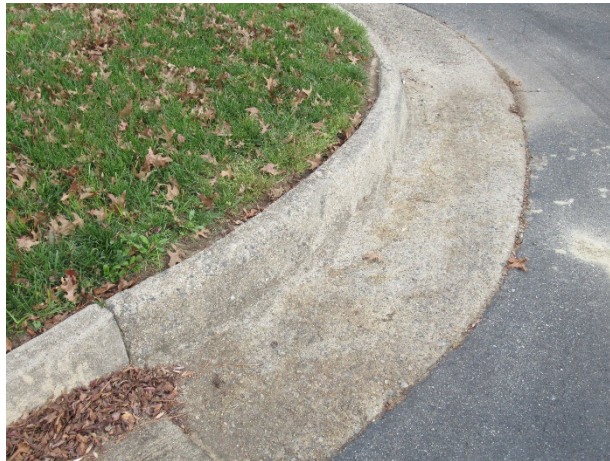
**Condition:** Good to fair overall with scaling evident

**Scaling**

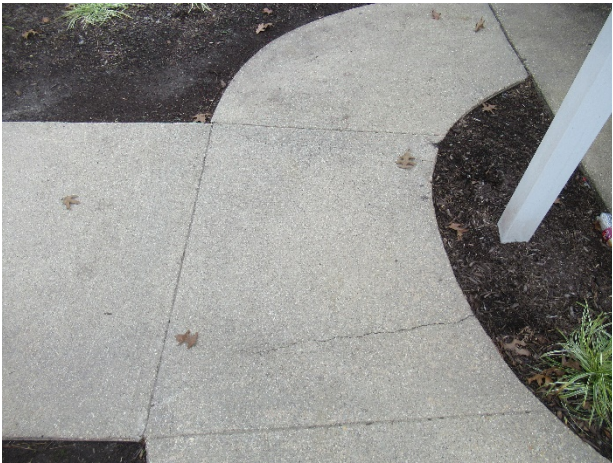
Concrete sidewalk crack

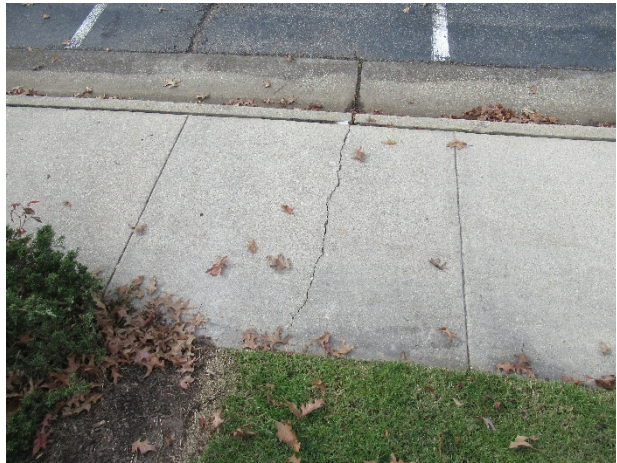
Concrete sidewalk crack

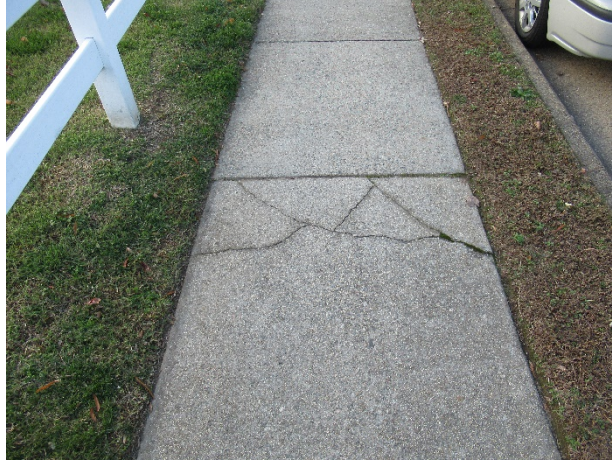
**Condition:** Good to fair overall with cracks evident

**Concrete sidewalk cracks**

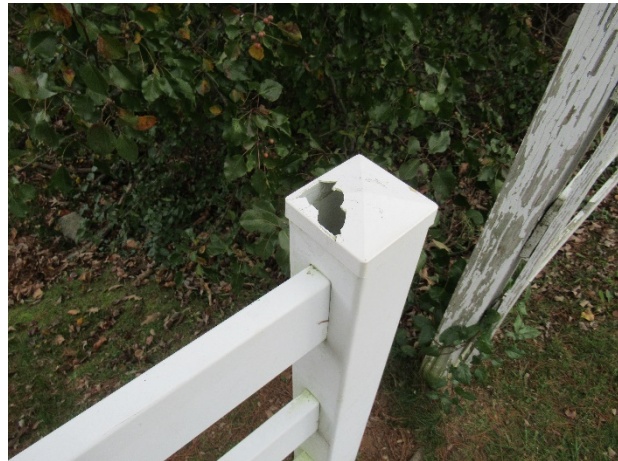
**Condition:** Fair overall with damage, displaced sections and organic growth evident

**Damage**

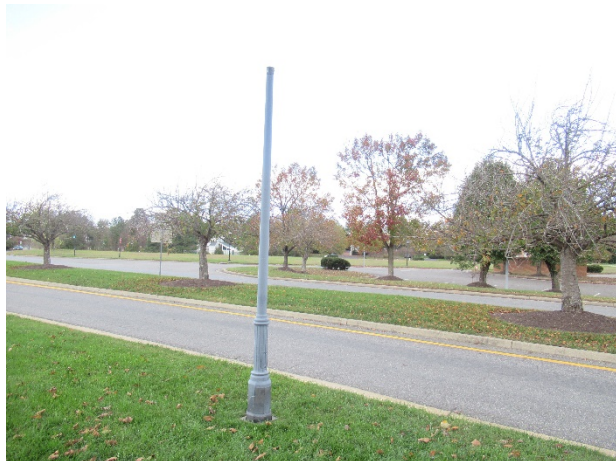
**Condition:** The landscape light poles and fixtures are in good overall condition. The parking lot and pool light poles and fixtures are in fair overall condition. The entrance light poles and fixtures are in fair to poor overall condition.

**Missing fixture**

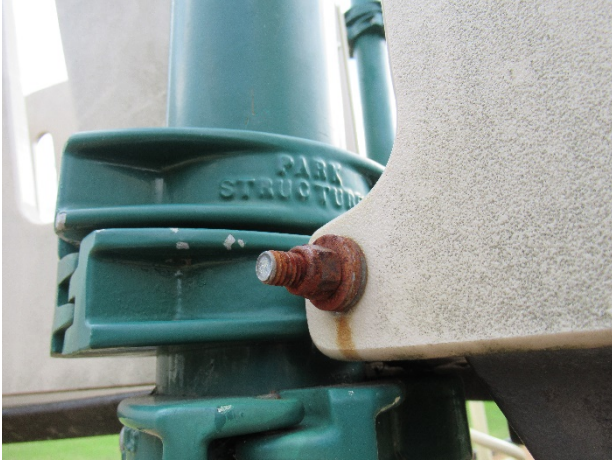
**Condition:** The playground at the clubhouse house is in fair to poor overall condition with rust, loose equipment and wear evident. The playground at Dugout Terrace is in fair overall condition with wear and finish deterioration evident.

**Rust at clubhouse playground**

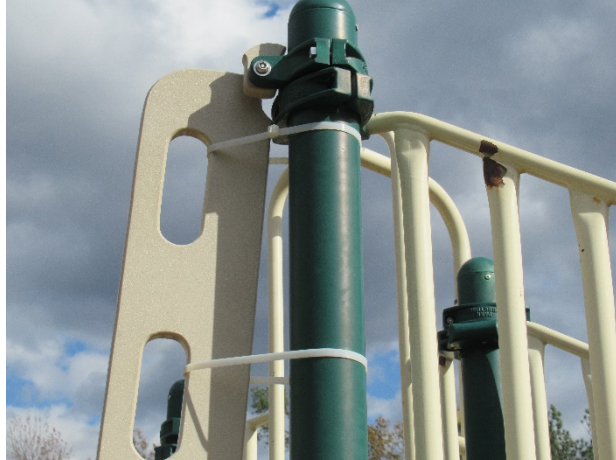
**Loose equipment at clubhouse**

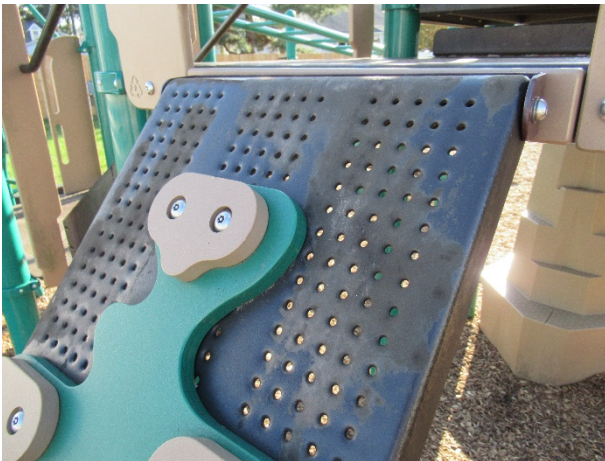
**Wear at Dugout Terrace**

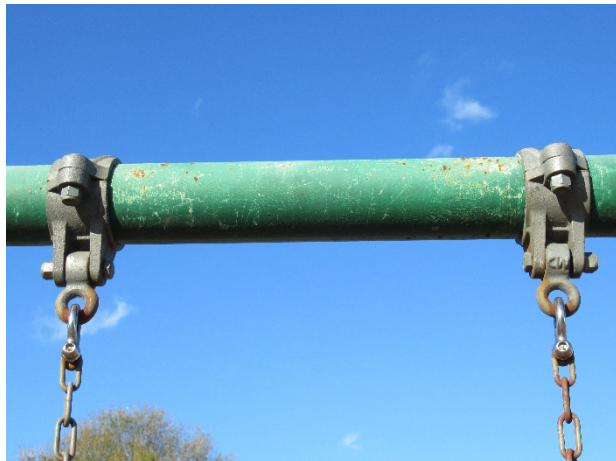
**Rust and finish deterioration at Dugout Terrace**

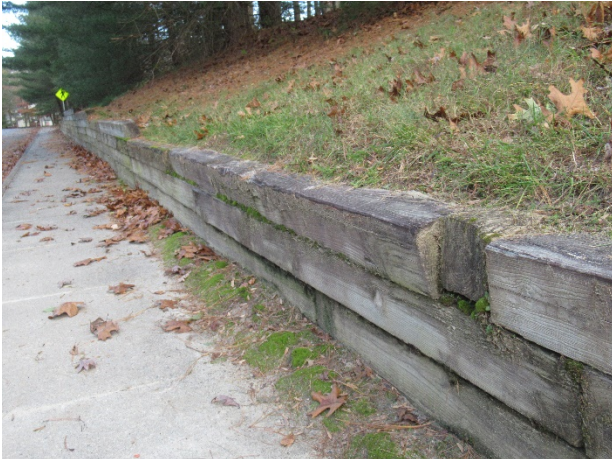
**Condition:** Fair to poor overall with leaning sections, organic growth, wood rot and water stains evident

**Timber retaining wall overview – Note: displacement and organic growth**

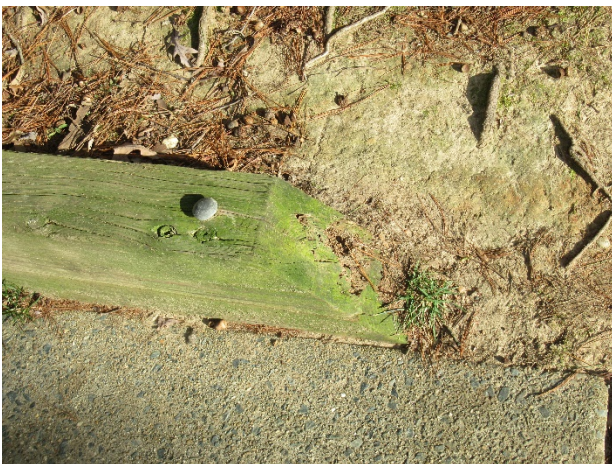
**Organic growth and wood rot**

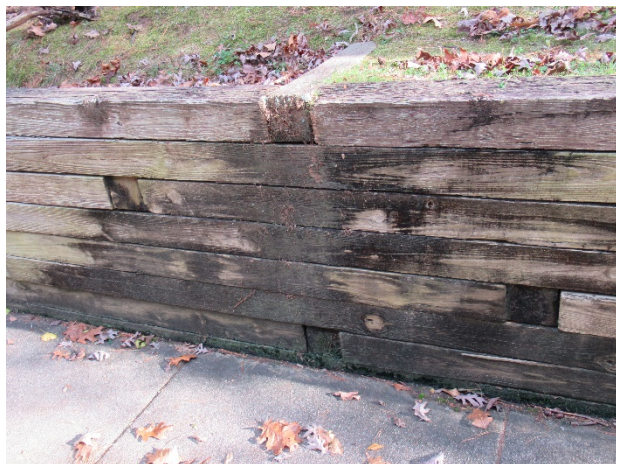
**Water stains**

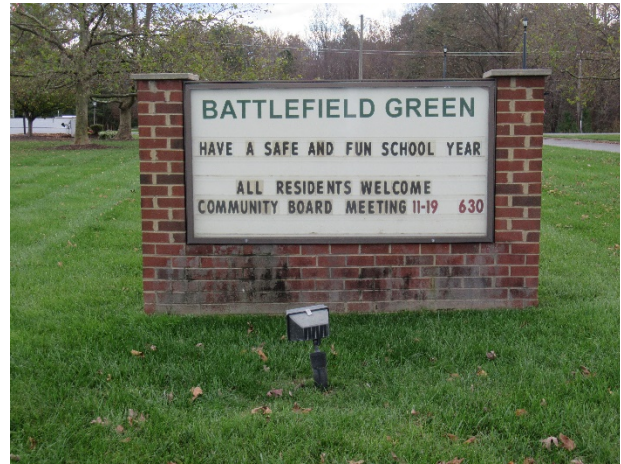
**Condition:** Good to fair overall with efflorescence, rusted fasteners and cracks evident

Entrance sign overview – *Note: efflorescence*

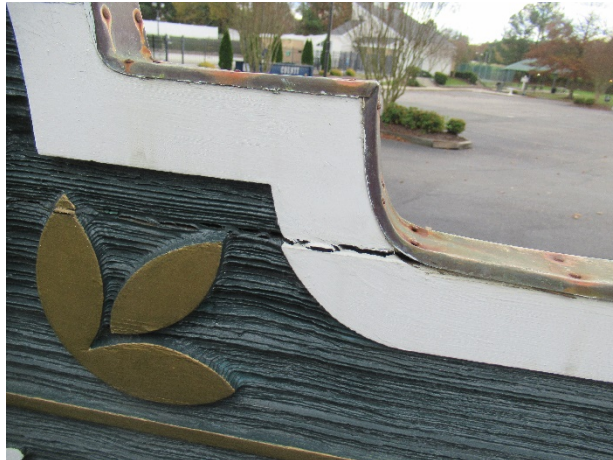
**Rusted fasteners and cracks**

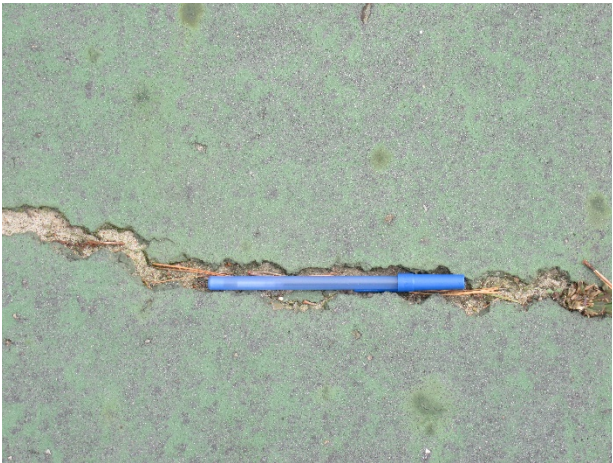
**Condition:** The court at the clubhouse is in fair overall condition with cracks evident. The court at Dugout Terrace is in good to fair overall condition with cracks and staining evident.

**Crack at clubhouse**

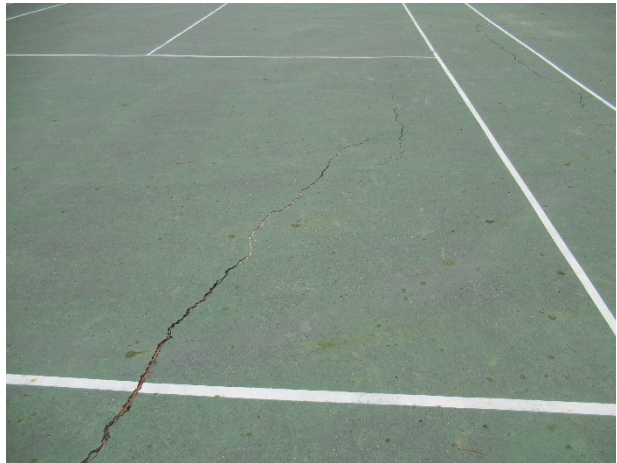
**Crack at clubhouse**

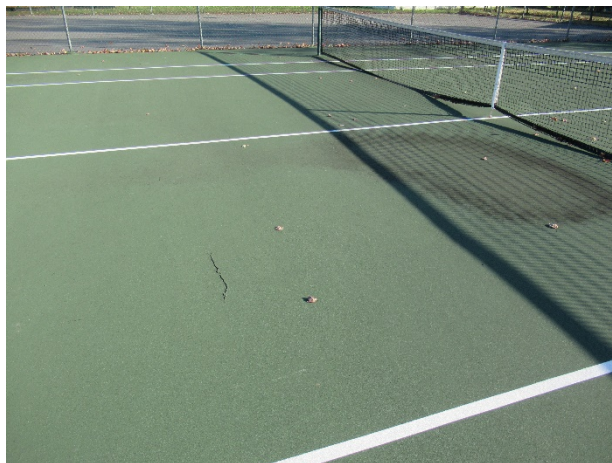
**Crack and staining at Dugout Terrace**

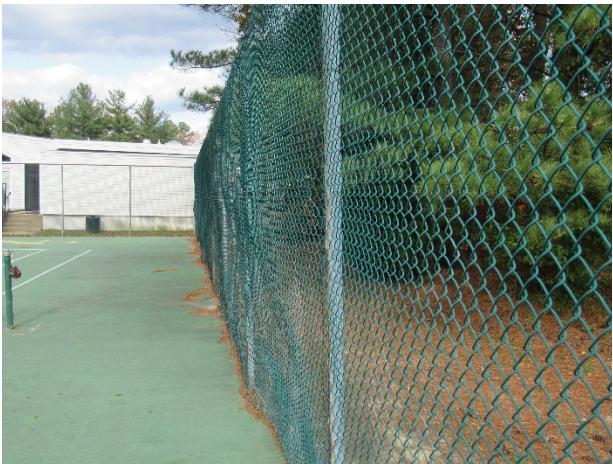
**Condition:** The clubhouse fence is fair overall with warping and finish deterioration evident. The Dugout Terrace fence is good to fair overall with warping evident.

Clubhouse fence overview – *Note: warping*

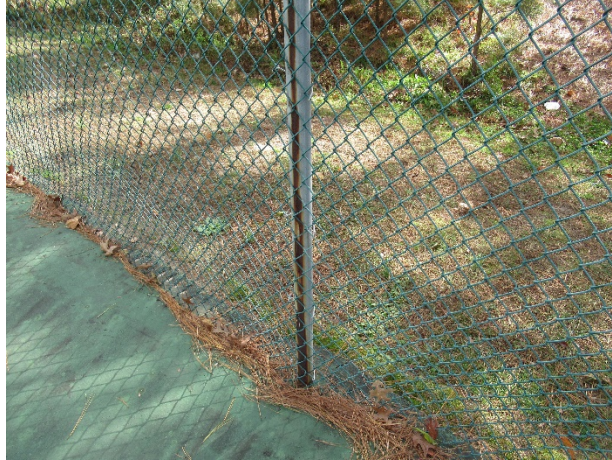
**Finish deterioration at the clubhouse**

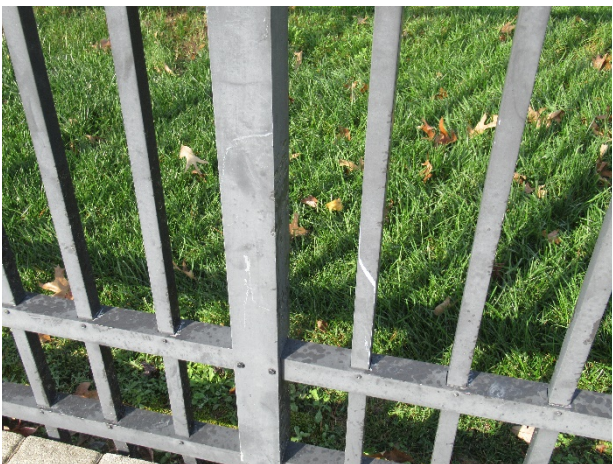
**Condition:** Fair overall condition with finish deterioration, replaced sections and displacement evident

Finish deterioration

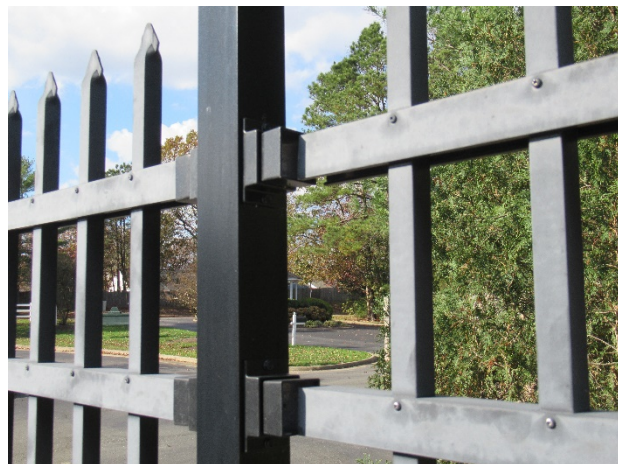
Replaced section and displacement

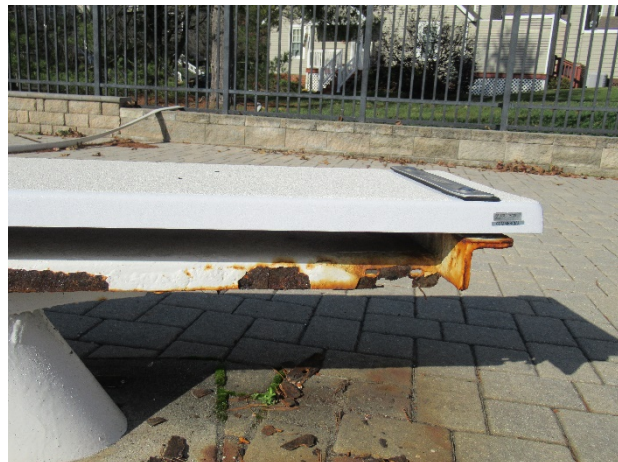
**Condition:** Good to fair overall. However, the diving board is in poor condition with rust evident.

Diving board rust

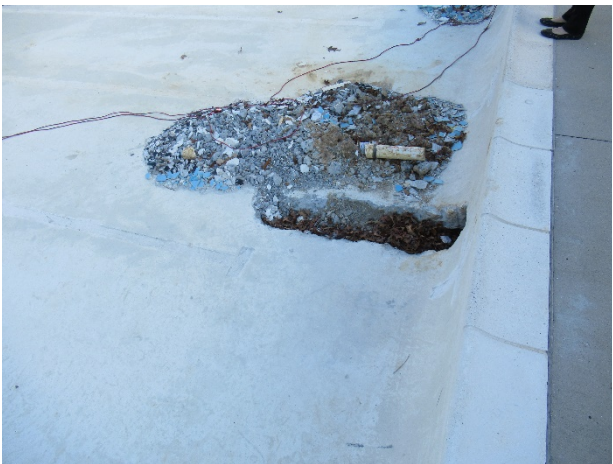
**Pool overview – Note: drain removal**

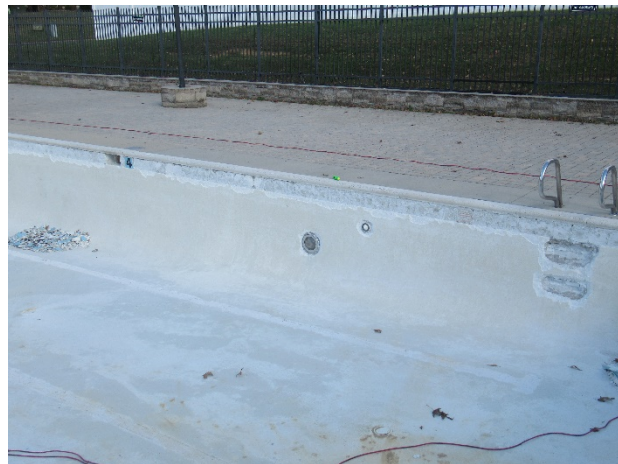
**Pool overview – Note: tile removed**
