# **RESERVE STUDY**

## **Battlefield Green Community Association, Inc.**

**Mechanicsville, Virginia  
November 17, 2020**

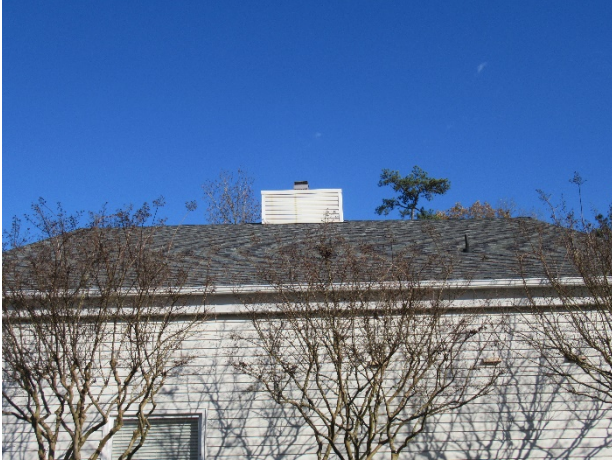
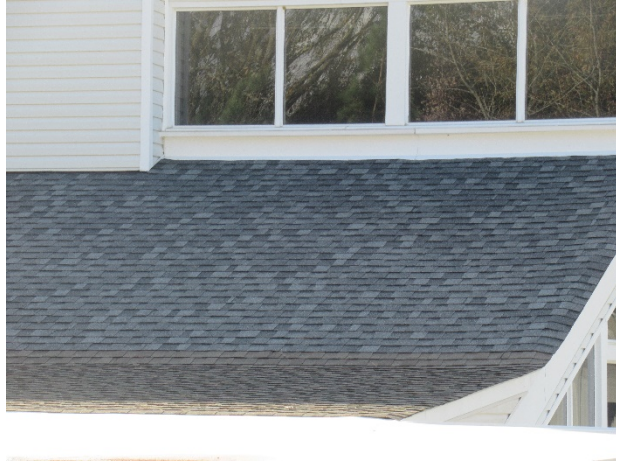
**Condition:** Good overall based from our visual inspection from the ground. Management does not report a history of leaks.

**Asphalt shingle roof overview**

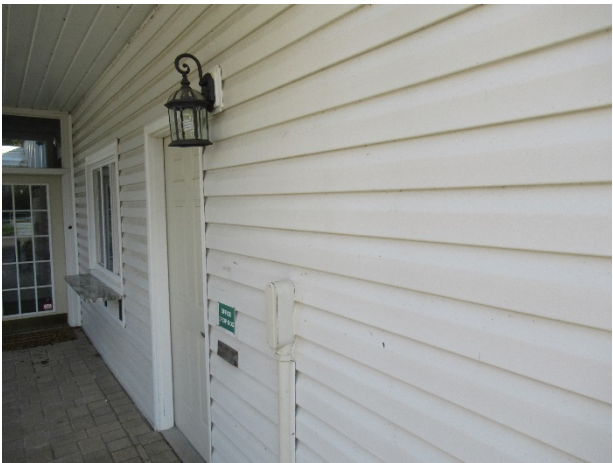
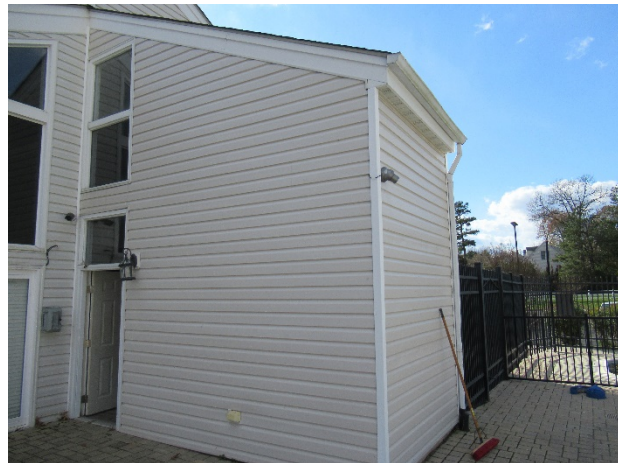
**Condition:** The replaced vinyl siding is in good overall condition. The original vinyl is in fair overall condition.

Vinyl siding overview

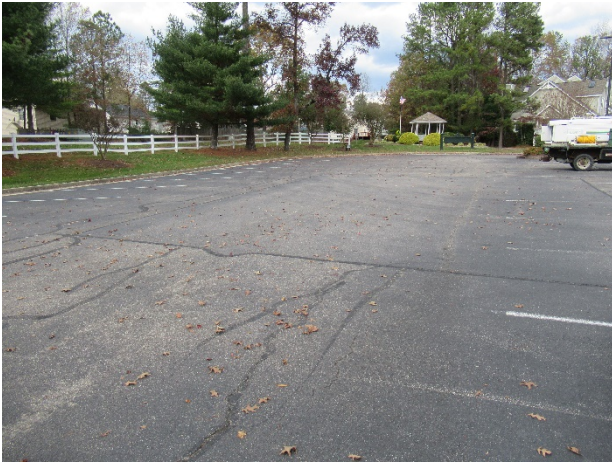
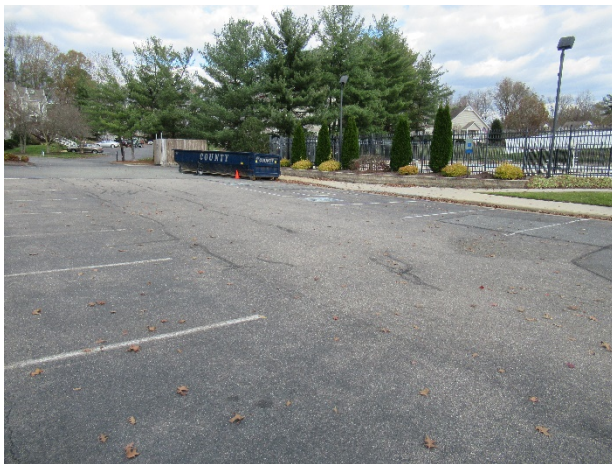
**Condition:** The asphalt pavement at the clubhouse is fair to poor overall with raveling and cracks evident. The asphalt pavement at Dugout Terrace is good overall with isolated cracks evident.

**Asphalt pavement overview**

application of two or more new lifts of asphalt. We recommend mill and overlayment on asphalt pavement that exhibits normal deterioration and wear. We recommend total replacement of asphalt pavement that exhibits severe deterioration, inadequate drainage, pavement that has been overlaid multiple times in the past or where the configuration makes overlayment not possible. Based on the apparent visual condition and configuration of the asphalt pavement, we recommend the mill and overlay method for initial repaving followed by the total replacement method for subsequent repaving at the clubhouse parking area. We recommend the total replacement method of repaving for Dugout Terrace.

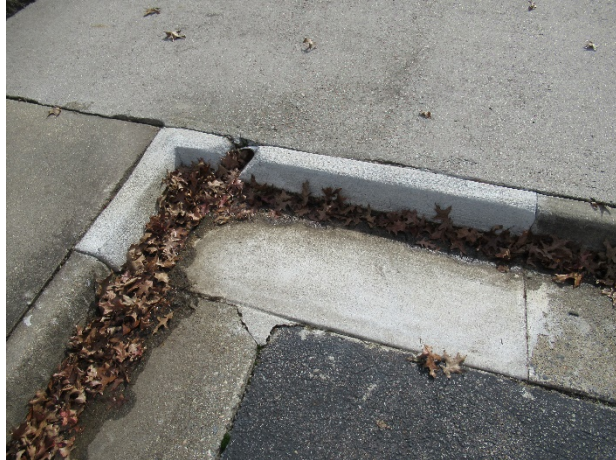
**Recently replaced section**

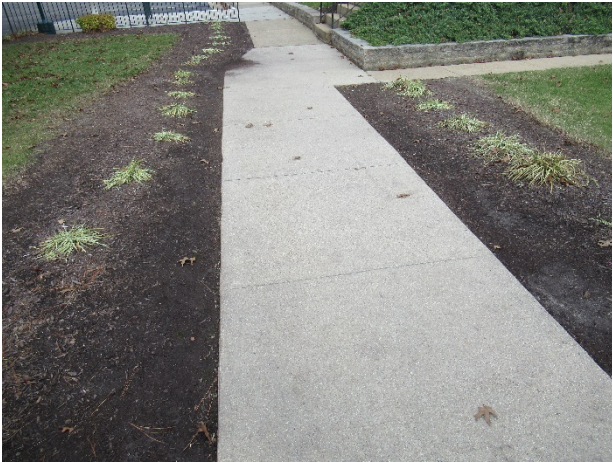
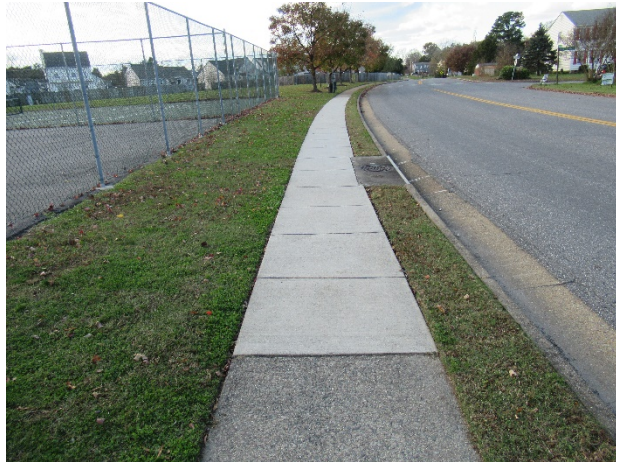
**Condition:** Good to fair overall with cracks evident

Concrete sidewalk overview

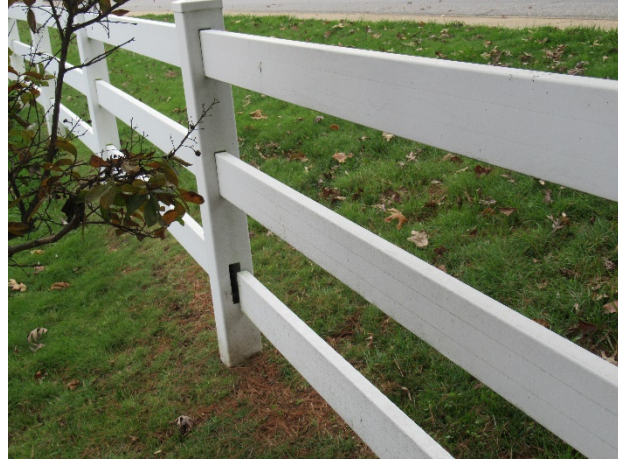
**Condition:** Fair overall with damage, displaced sections and organic growth evident

**Vinyl fence displacement**

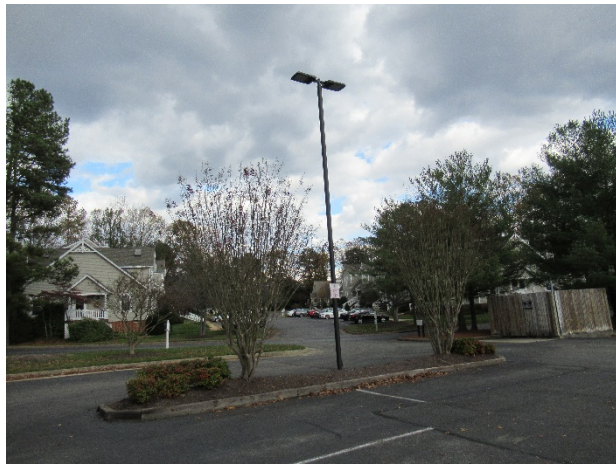
**Condition:** The landscape light poles and fixtures are in good overall condition. The parking lot and pool light poles and fixtures are in fair overall condition. The entrance light poles and fixtures are in fair to poor overall condition.

**Parking lot light pole and fixture overview**

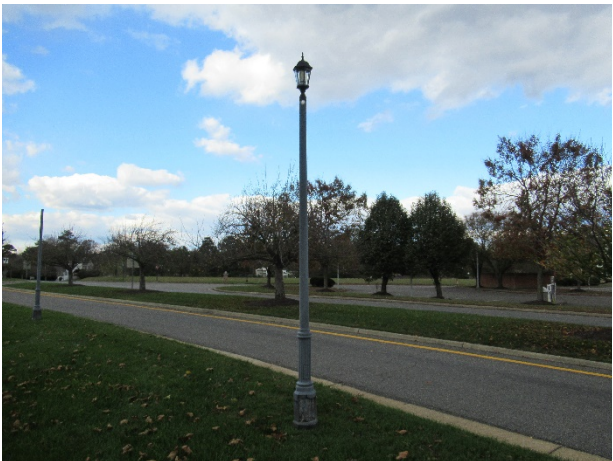
**Entrance light pole and fixture overview**

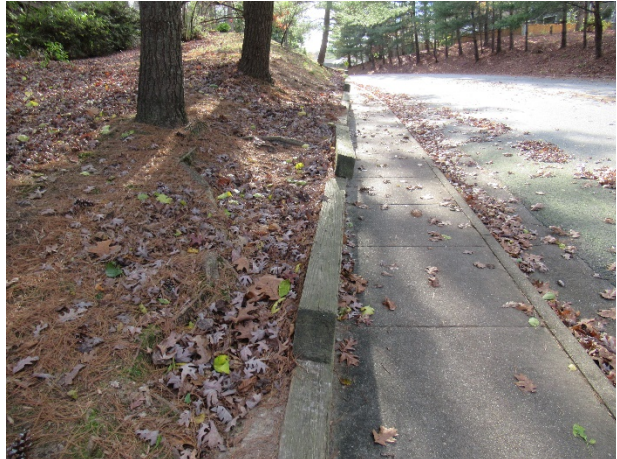
**Condition:** Fair to poor overall with leaning sections, organic growth, wood rot and water stains evident

**Timber retaining wall overview – Note: lean**

**Component Detail Notes:** We advise Battlefield Green replace with a modular, interlocking dry-set masonry retaining wall system. The cost of dry-set masonry retaining walls is similar to the cost of timber walls. However, dry-set masonry retaining walls offer a longer useful life of up to 35 years and lower total maintenance costs. The following schematic depicts the typical components of a retaining wall system although it may not reflect the actual configuration at Battlefield Green:

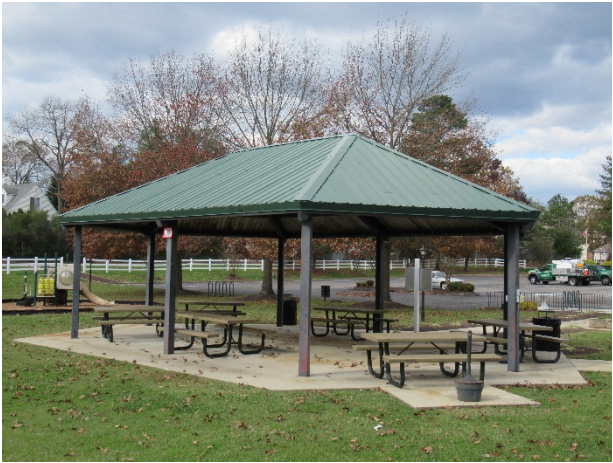
**Condition:** Good to fair overall

**Metal roof overview**

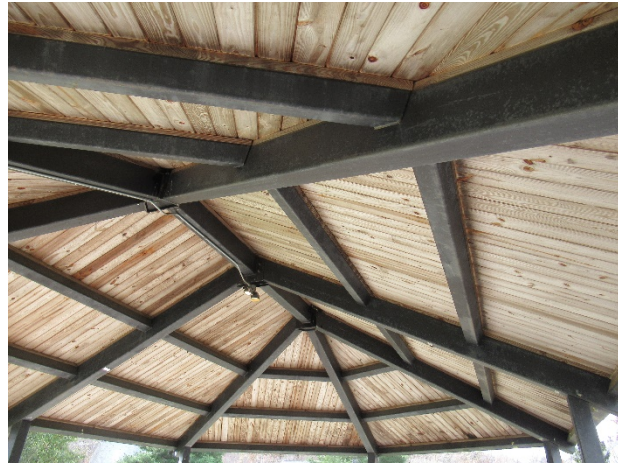
**Metal roof underside**
