# **RESERVE STUDY**

## **Battlefield Green Community Association, Inc.**

**Mechanicsville, Virginia  
November 17, 2020**

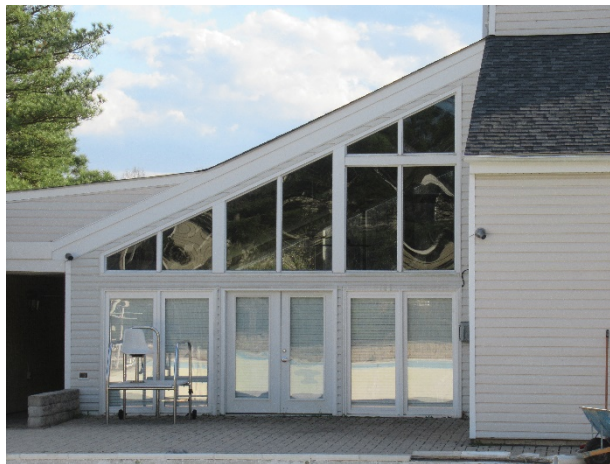
**Condition:** Reported satisfactory

**Window and door overview**

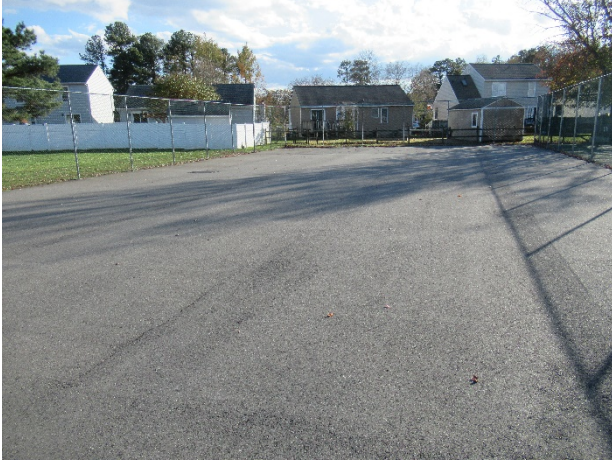
**Condition:** The asphalt pavement at the clubhouse is fair to poor overall with raveling and cracks evident. The asphalt pavement at Dugout Terrace is good overall with isolated cracks evident.

**Dugout Terrace asphalt pavement court**

application of two or more new lifts of asphalt. We recommend mill and overlayment on asphalt pavement that exhibits normal deterioration and wear. We recommend total replacement of asphalt pavement that exhibits severe deterioration, inadequate drainage, pavement that has been overlaid multiple times in the past or where the configuration makes overlayment not possible. Based on the apparent visual condition and configuration of the asphalt pavement, we recommend the mill and overlay method for initial repaving followed by the total replacement method for subsequent repaving at the clubhouse parking area. We recommend the total replacement method of repaving for Dugout Terrace.

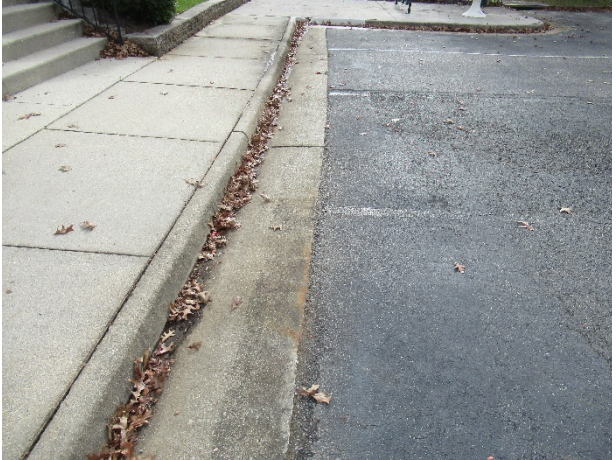
**Condition:** Good to fair overall with scaling evident

**Concrete curb overview**

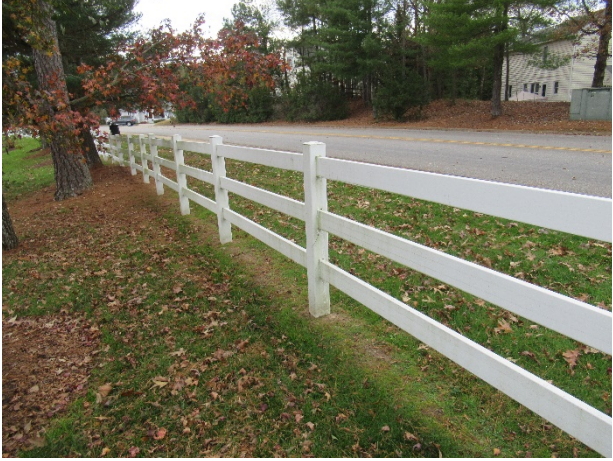
**Condition:** Fair overall with damage, displaced sections and organic growth evident

**Vinyl fence overview**

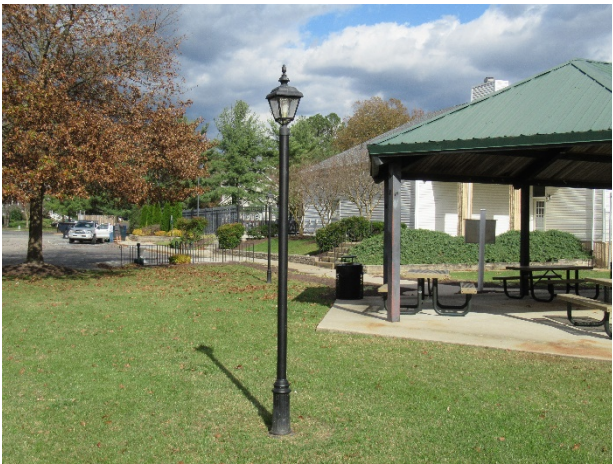
**Condition:** The landscape light poles and fixtures are in good overall condition. The parking lot and pool light poles and fixtures are in fair overall condition. The entrance light poles and fixtures are in fair to poor overall condition.

**Landscape light pole and fixture overview**

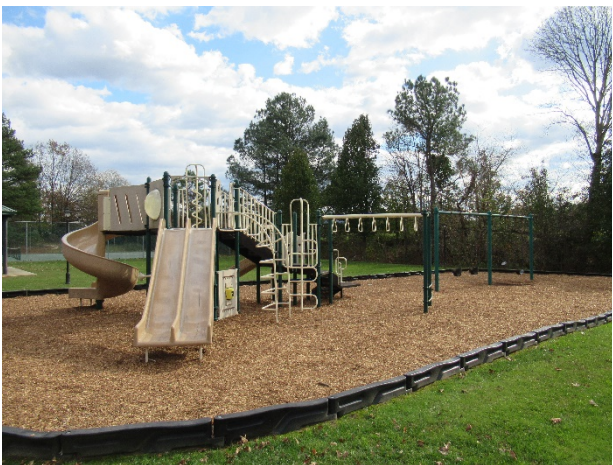
**Condition:** The playground at the clubhouse house is in fair to poor overall condition with rust, loose equipment and wear evident. The playground at Dugout Terrace is in fair overall condition with wear and finish deterioration evident.

**Clubhouse playground overview**

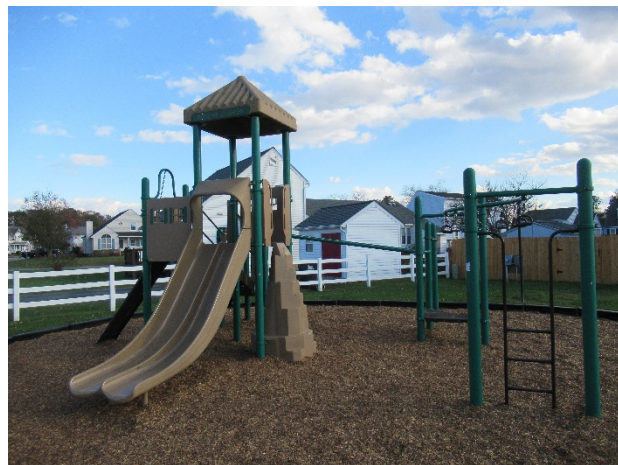
**Dugout Terrace playground overview**

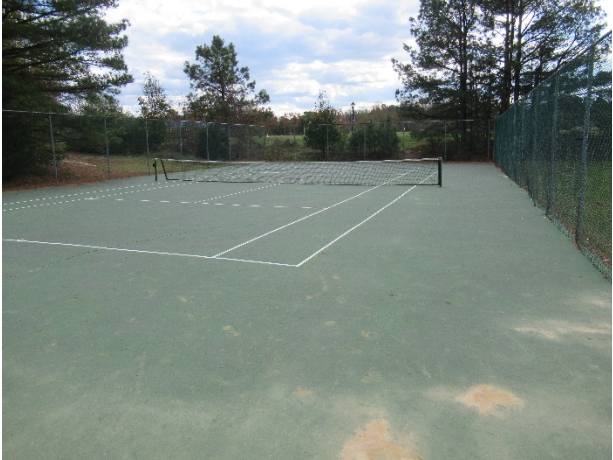
**Condition:** The court at the clubhouse is in fair overall condition with cracks evident. The court at Dugout Terrace is in good to fair overall condition with cracks and staining evident.

**Clubhouse tennis court overview**

**Component Detail Notes:** Prior to the application of the color coat, the Association should require the contractor to rout and fill all cracks with hot emulsion. This deters water infiltration and further deterioration of the asphalt playing surface.

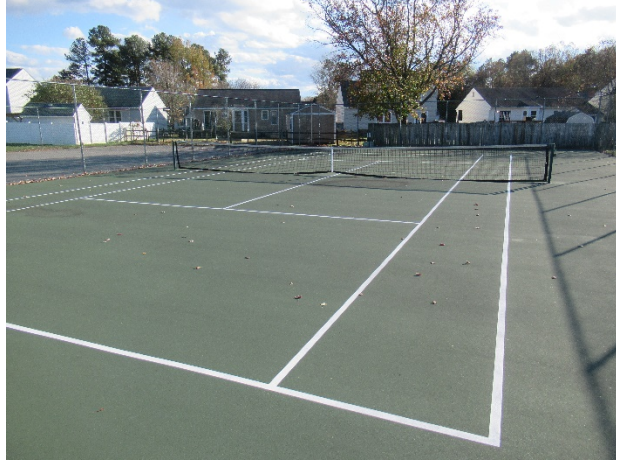
**Dugout Terrace tennis court overview**

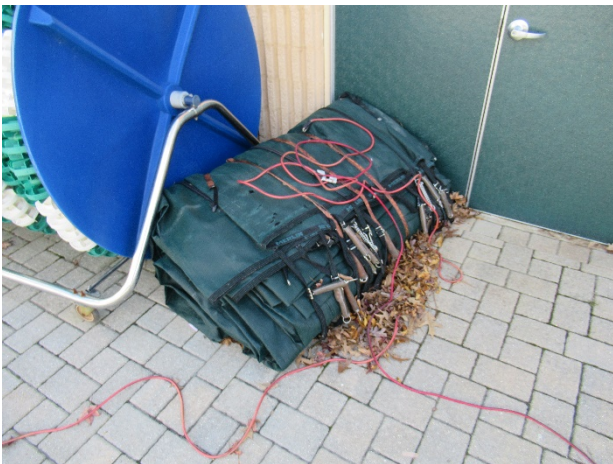
**Condition:** Fair overall with tears evident

Cover overview

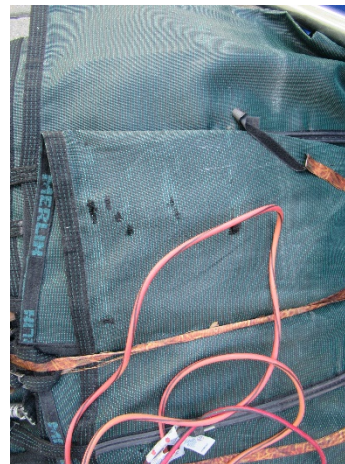
Tears

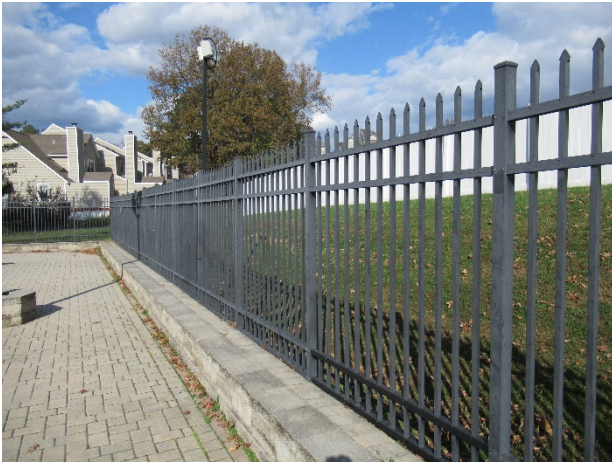
**Condition:** Fair overall condition with finish deterioration, replaced sections and displacement evident

Fence overview

- Annually:
  - Inspect and repair loose fasteners or sections, and damage
  - Repair leaning sections and clear vegetation from fence areas which could cause damage

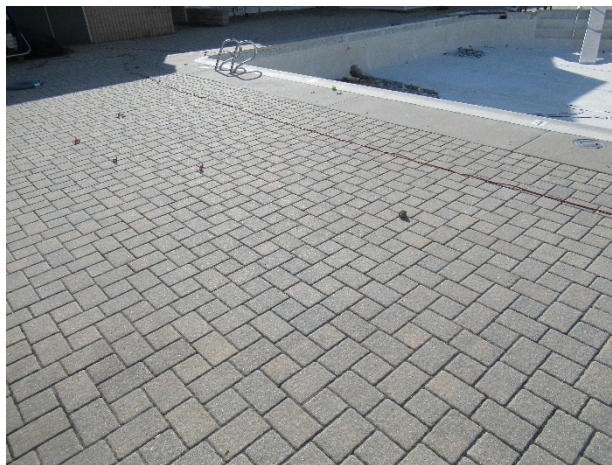
**Conditions:** Visually appears in good condition. The concrete floors and walls have a plaster finish. This finish makes it difficult to thoroughly inspect the concrete structure during a noninvasive visual inspection.

**Deck overview**
